TECH TIP

MERCURY VILLAGER/NISSAN QUEST NO REAR BLOWER OPERATION

MODEL YEARS: 1997-1993

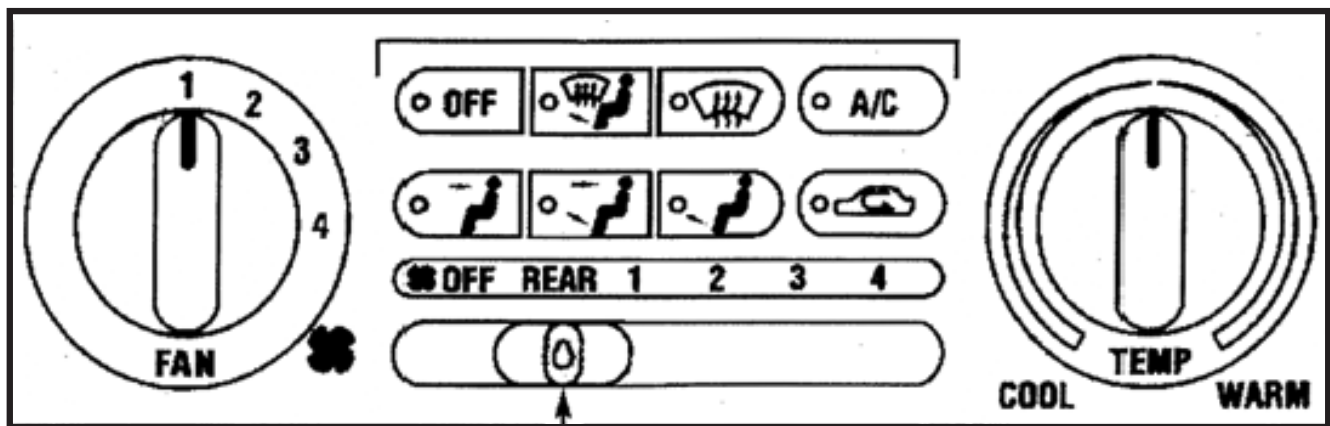
If continuity does not exist, remove the top cover of the HVAC control panel. Carefully check the printed circuit board for cracks or a broken solder joint. A broken solder joint can generally be found near one of the corners.

Two possible repairs may be done. If only the solder joint is broken, re-solder the joint (do not use acid core solder). Should the circuit board be cracked beyond repair, replace the HVAC control panel with a new assembly.
