**4 SEASONS**  
Your Automotive PARTner

## DYK TECH TIP # 101

### Part No. 75865

### Some call it the “Buick Niagara”...

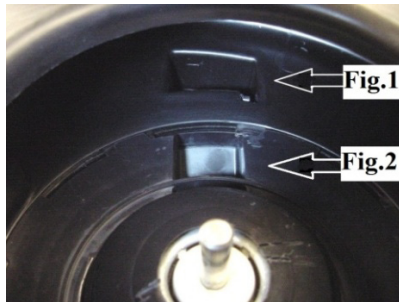
The O.E Blower Motor flange has a design flaw where water can accumulate allowing bacteria and mold to grow ( Fig. 2 ). There is also a hole in the blower motor case that allows water to drain down the vent tube and into the motor (Fig. 1 & 3). The design of the motor cover allows for the accumulation of water causing the motor to rust, which can result in premature failure ( Fig. 4 & 5).

Four Seasons developed a protruding vent tube design that helps stop the water from flowing into the motor.
