GM TRUCK HIGH PRESSURE CONDITION

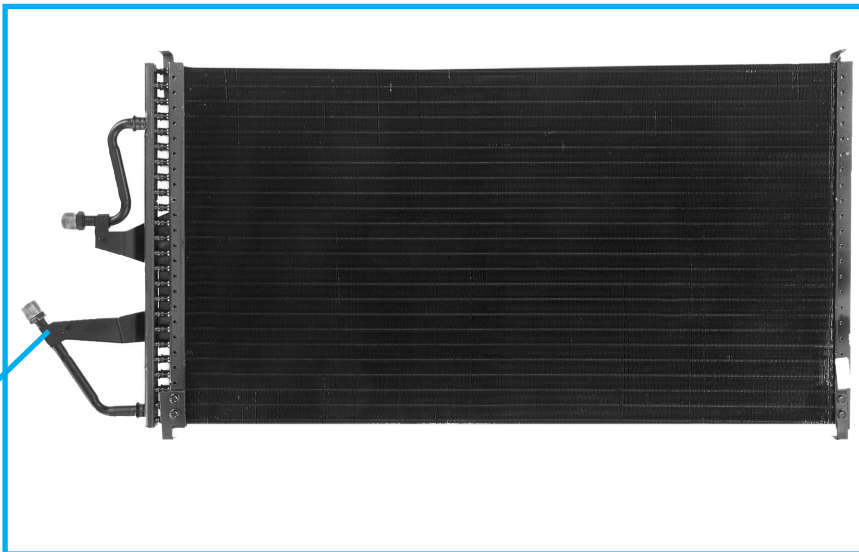
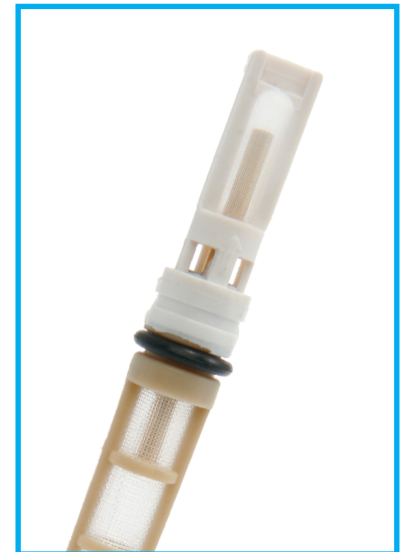
Orifice
Tube

A common complaint is the head pressure soars to abnormally high readings after charging about 8 oz. of refrigerant. Generally, this complaint occurs after the condenser has been replaced or flushed. The problem is with the design of the condenser. First, both fittings have the same threads so the lines can be reversed when reconnected. Second, the condenser will actually mount upside down. In either case, the compressor discharge line would direct refrigerant straight to the orifice tube, which creates the high-pressure condition.

When diagnosing this complaint, inspect condenser mounting and hose routing. The discharge hose (from the compressor) connects to the top on the condenser (inlet). The orifice tube mounts in the bottom of the condenser (outlet to the evaporator). The outlet tube of the condenser has a 45° upward angle.

If the lines and orifice tube locations are correct, and the system still has high head pressure, the vehicle will need to be tested for a possible internal restriction or airflow problem.
