GM TRUCK HIGH PRESSURE CONDITION

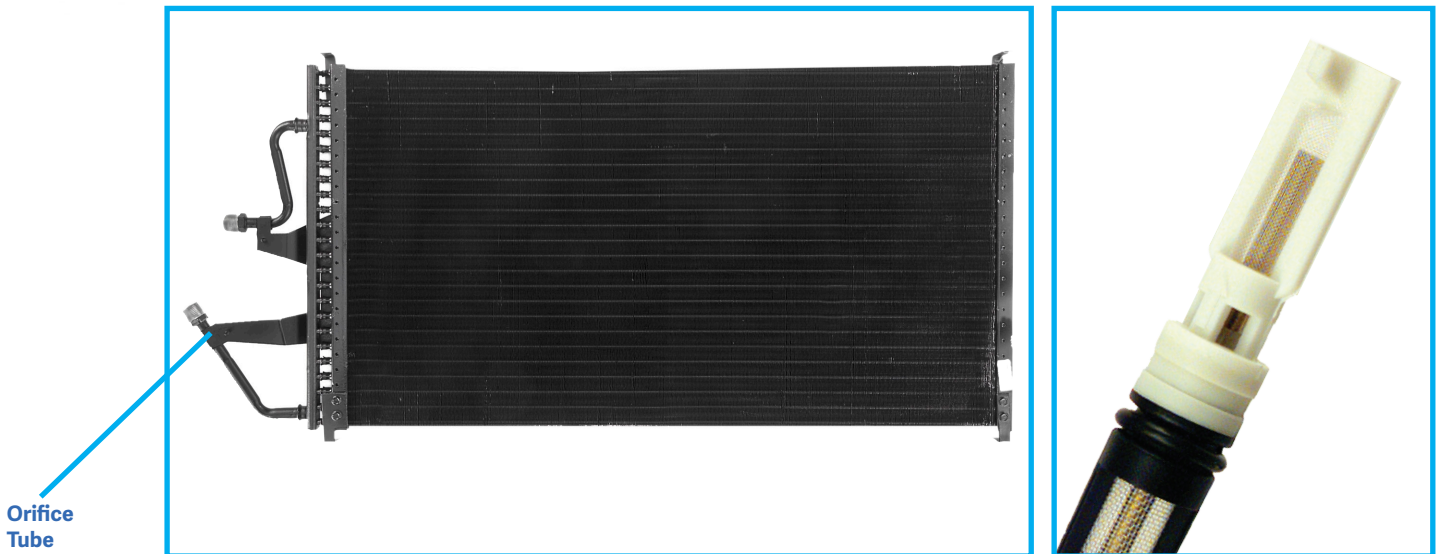
A common complaint is the head pressure soars to abnormally high readings after charging about 8 oz. of refrigerant. Generally, this complaint occurs after the condenser has been replaced or flushed. The problem is with the design of the condenser. First, both fittings have the same threads so the lines can be reversed when reconnected. Second, the condenser will actually mount upside down. In either case, the compressor discharge line would direct refrigerant straight to the orifice tube, which creates the high-pressure condition.

When diagnosing this complaint, inspect condenser mounting and hose routing. The discharge hose (from the compressor) connects to the top on the condenser (inlet). The orifice tube mounts in the bottom of the condenser (outlet to the evaporator). The outlet tube of the condenser has a 45° upward angle.

If the lines and orifice tube locations are correct, and the system still has high head pressure, the vehicle will need to be tested for a possible internal restriction or airflow problem.
