# QUALITY ADVANTAGE BLOWER MOTORS

### Four Seasons® P/N 75777 & 75778 Unit

# BLOWER MOTORS

### Four Seasons® 75850 Unit

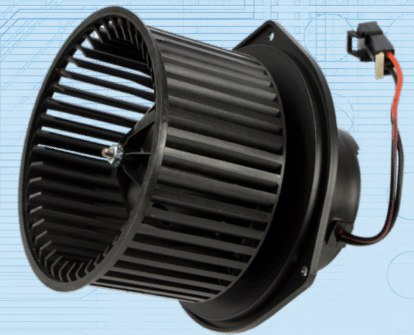
Four Seasons® provides a hassle free, drop-in-replacement design that does not require any kind of special installation kit. With the installer in mind, we designed a motor that would not only fit and perform as needed, but would also be easier to install, saving both time and money.

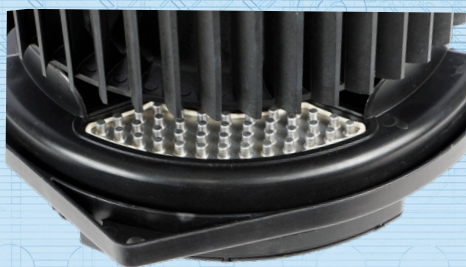
Integrated cooling tube for extended motor life
