H6 SERIES COMPRESSOR BODY LEAKS

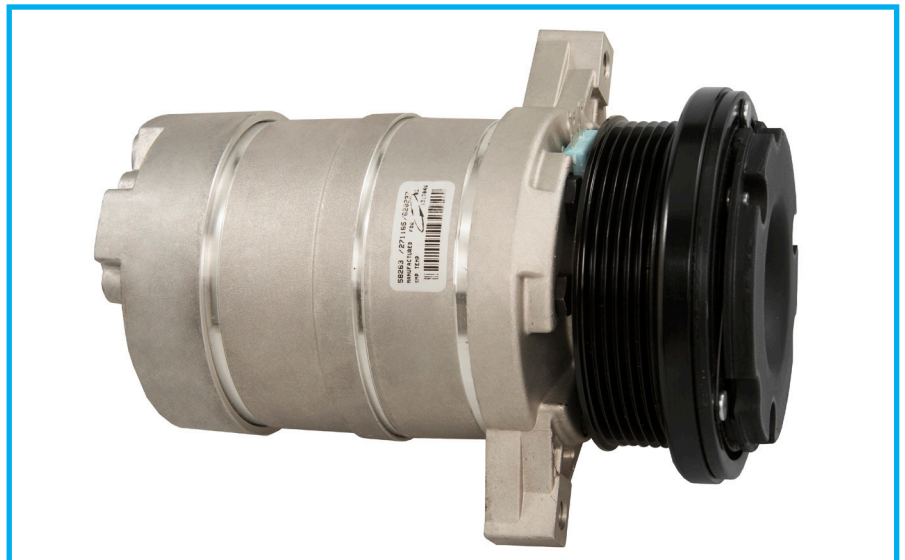
- **SINGLE SOLID BRACKET** –Typically used with the HT6 – There have been some stories of these brackets warping. Most of these brackets are of cast aluminum so warping would be difficult. However, if the bolts are improperly torqued, as the bracket material is heated and cooled in the engine compartment, the bracket and the compressor would conform (twist or warp) to each other. If the bolsters or pads of the cradle that the compressor sits on are not 100% square and if the compressor does not lay flat on all four pads, a twisting or rocking action could present a problem even if the compressor is properly torqued. If the compressor does not sit solidly on all four positions, and the compressor is torqued down into the mounting cradle, the non-doweled compressor body will twist and invariably leak or make noise.

To assure a solid fit, place the compressor in the cradle and try to rock it. If the compressor rocks back and forth, place a shim or standard washer between the compressor and the bracket. Torque the four bolts evenly and alternately but make sure the compressor does not rock in the cradle before the bolts are torqued.

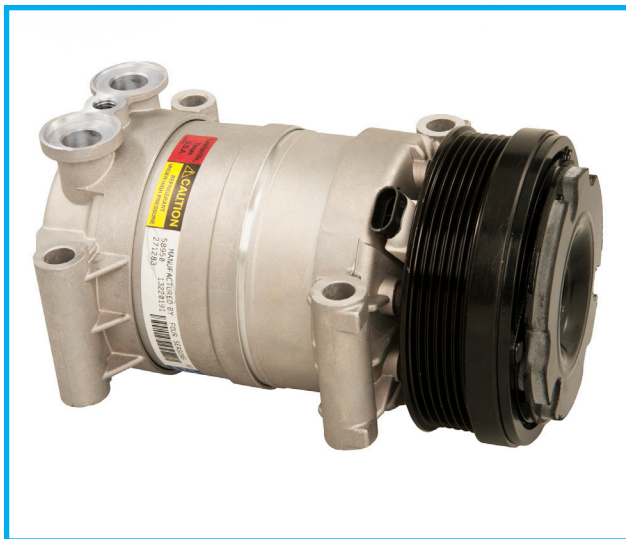
- **DUAL BRACKET** – used with DA6, HD6 and HR6 – Most installers will start the four compressor mounting bolts and then use an air ratchet to tighten them down. If there is any alignment variation between the two brackets, the tightening process will twist the case and create a body leak or noise. To assure that the brackets conform to the compressor and not the compressor to the brackets, loosen the brackets from the engine block. Snug down the compressor mounting bolts. Tighten the bracket to engine bolts then torque the compressor mounting bolts.

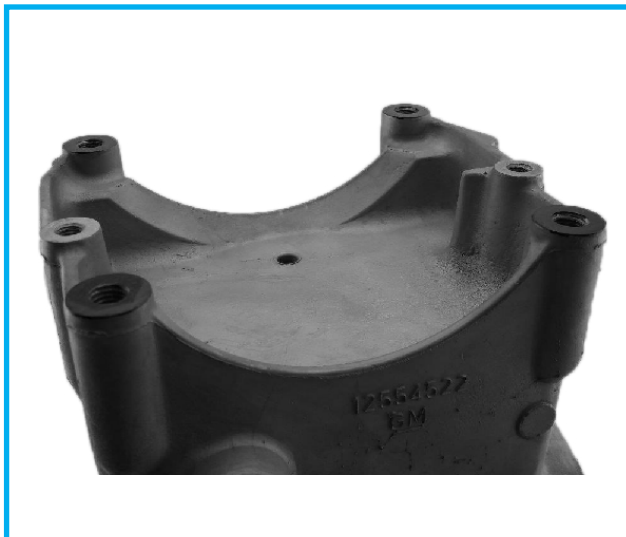
Not only will the above procedures prevent body seal leaks but will also obviously increase the compressor life span, plus reduce vibration and noise. Any major amount of twisting of the compressor housings will cause the cylinders to be out of alignment. This alignment condition may not be enough to see with the naked eye but will cause decreased performance and decrease the life of the compressor. This compressor family was designed without an alignment dowel pin, allowing for a small amount of case twisting to occur. Possibly the OEM designer removed the pin for easier assembly purposes, since they did not consider it to be critical to this particular family of compressors. However, a moderate amount of case twisting will typically lead to a case leak, and if not quickly detected, it will possibly cause compressor failure.
