## H6 SERIES COMPRESSOR BODY LEAKS

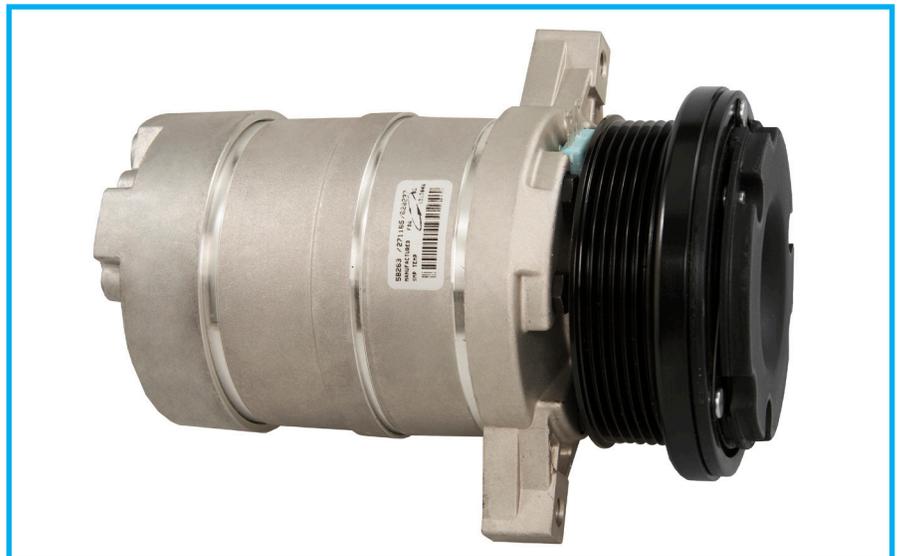
- **SINGLE SOLID BRACKET** –Typically used with the HT6 – There have been some stories of these brackets warping. Most of these brackets are of cast aluminum so warping would be difficult. However, if the bolts are improperly torqued, as the bracket material is heated and cooled in the engine compartment, the bracket and the compressor would conform (twist or warp) to each other. If the bolsters or pads of the cradle that the compressor sits on are not 100% square and if the compressor does not lay flat on all four pads, a twisting or rocking action could present a problem even if the compressor is properly torqued. If the compressor does not sit solidly on all four positions, and the compressor is torqued down into the mounting cradle, the non-doweled compressor body will twist and invariably leak or make noise.

To assure a solid fit, place the compressor in the cradle and try to rock it. If the compressor rocks back and forth, place a shim or standard washer between the compressor and the bracket. Torque the four bolts evenly and alternately but make sure the compressor does not rock in the cradle before the bolts are torqued.

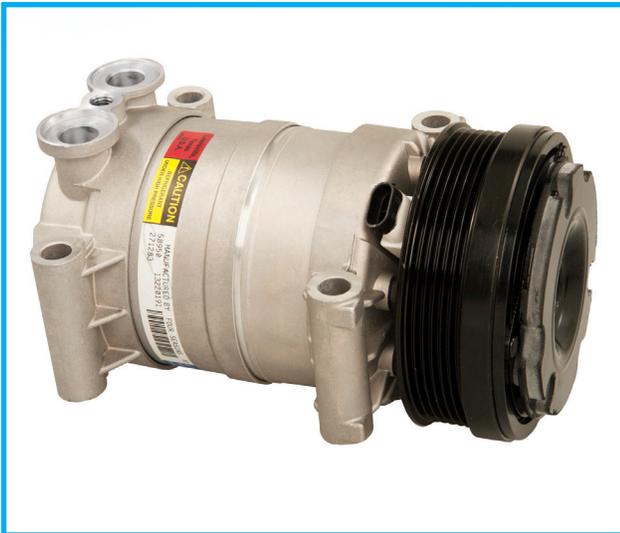
- **DUAL BRACKET** – used with DA6, HD6 and HR6 – Most installers will start the four compressor mounting bolts and then use an air ratchet to tighten them down. If there is any alignment variation between the two brackets, the tightening process will twist the case and create a body leak or noise. To assure that the brackets conform to the compressor and not the compressor to the brackets, loosen the brackets from the engine block. Snug down the compressor mounting bolts. Tighten the bracket to engine bolts then torque the compressor mounting bolts.

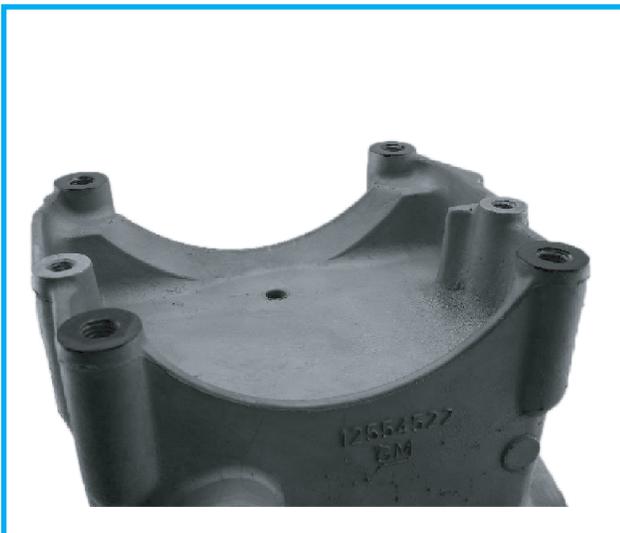
Not only will the above procedures prevent body seal leaks but will also obviously increase the compressor life span, plus reduce vibration and noise. Any major amount of twisting of the compressor housings will cause the cylinders to be out of alignment. This alignment condition may not be enough to see with the naked eye but will cause decreased performance and decrease the life of the compressor. This compressor family was designed without an alignment dowel pin, allowing for a small amount of case twisting to occur. Possibly the OEM designer removed the pin for easier assembly purposes, since they did not consider it to be critical to this particular family of compressors. However, a moderate amount of case twisting will typically lead to a case leak, and if not quickly detected, it will possibly cause compressor failure.

Any amount of case twisting could be considered one of the causes for premature piston wear, noisy operation, and eventual compressor failure.
