A/C FILTER SCREEN KIT

PART NO. 39999

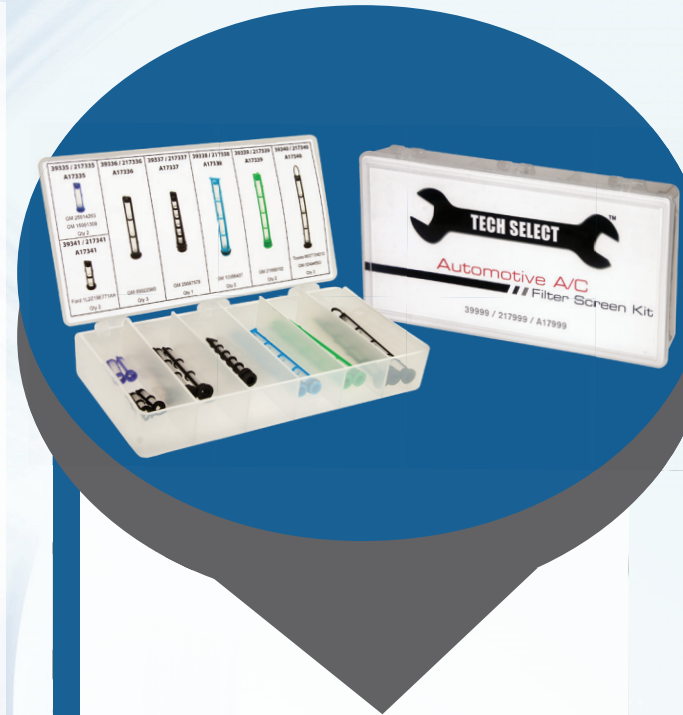
Four Seasons® TEMP Select™ brand A/C Filter Screen Kit offers highly popular in-line filters in a convenient, lightweight box. The individual compartments and graphic card with O.E part number reference, make it easy to find what you're looking for in a more timely and efficient manner.

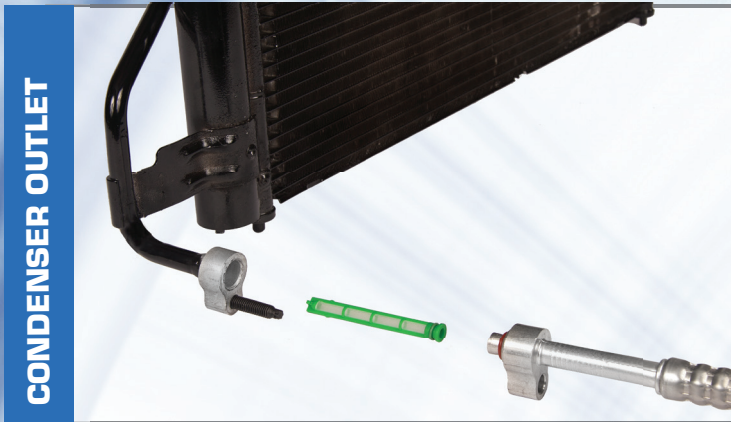
LOCATION

Many of today's A/C systems employ an In-Line Filter Screen before the Expansion Valve in order to trap debris and dissipate refrigerant oil. These Filters should be inspected and/or replaced as part of any A/C system repair, but especially crucial when there has been a catastrophic compressor failure.

LIQUID LINE FILTER
