MERCURY VILLAGER/NISSAN QUEST NO REAR BLOWER OPERATION

YEAR MODELS: 1993-1997

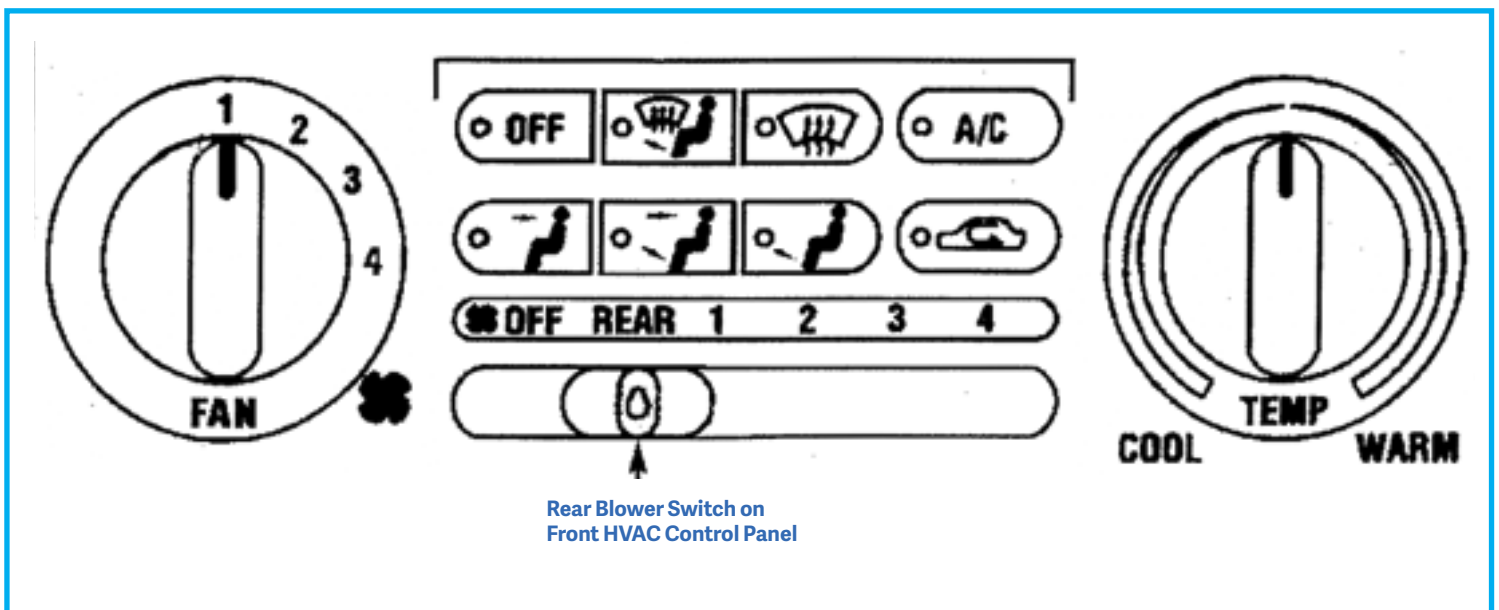
Remove the front HVAC control panel. Insure that the blower switch, for the rear blower motor, is either in the "REAR" position or on one of the speed selections. Next, check continuity between the wires of the two-pin connector (ground circuit) while still connected to the control panel.

If continuity does not exist, remove the top cover of the HVAC control panel. Carefully check the printed circuit board for cracks or a broken solder joint. A broken solder joint can generally be found near one of the corners.

Two possible repairs may be done. If only the solder joint is broken, re-solder the joint (Do Not use acid core solder). Should the circuit board be cracked beyond repair, replace the HVAC control panel with a new assembly.
